CERL Technical Report 99/37  
May 1999

# **Robotic Underwater Corrosion Inspection/Assessment of Sheet Pile Along Two Rivers at Cleveland, Ohio**

## **Cuyahoga River Bulkhead Study: Phase 2 Report**

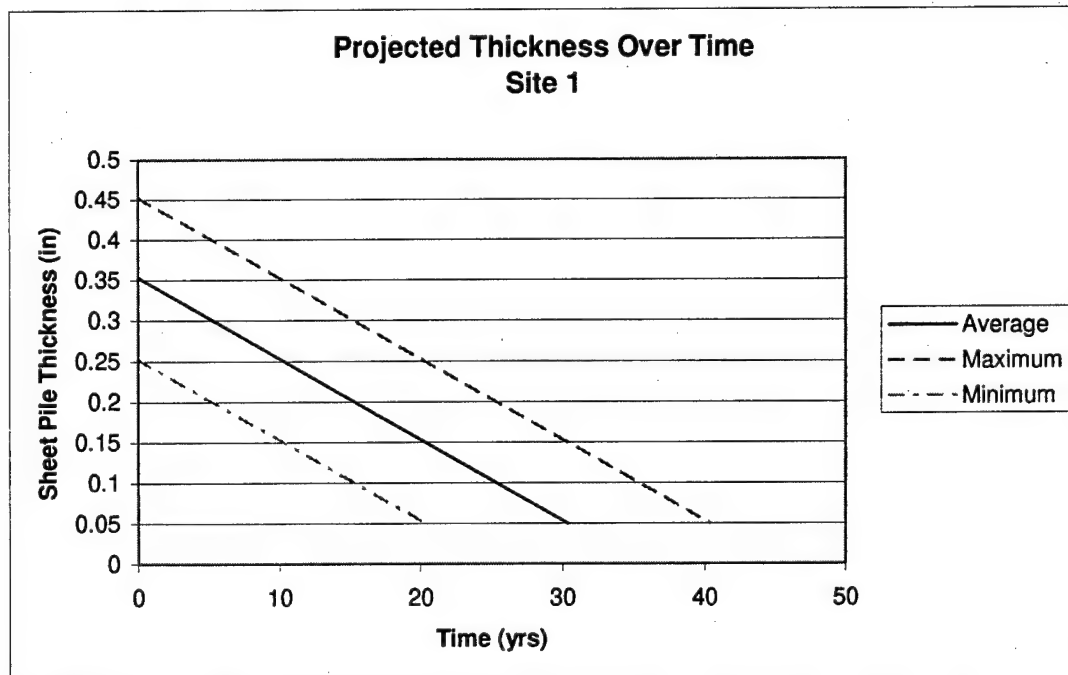
**Figure 10. Site 1 projected thickness over time.**

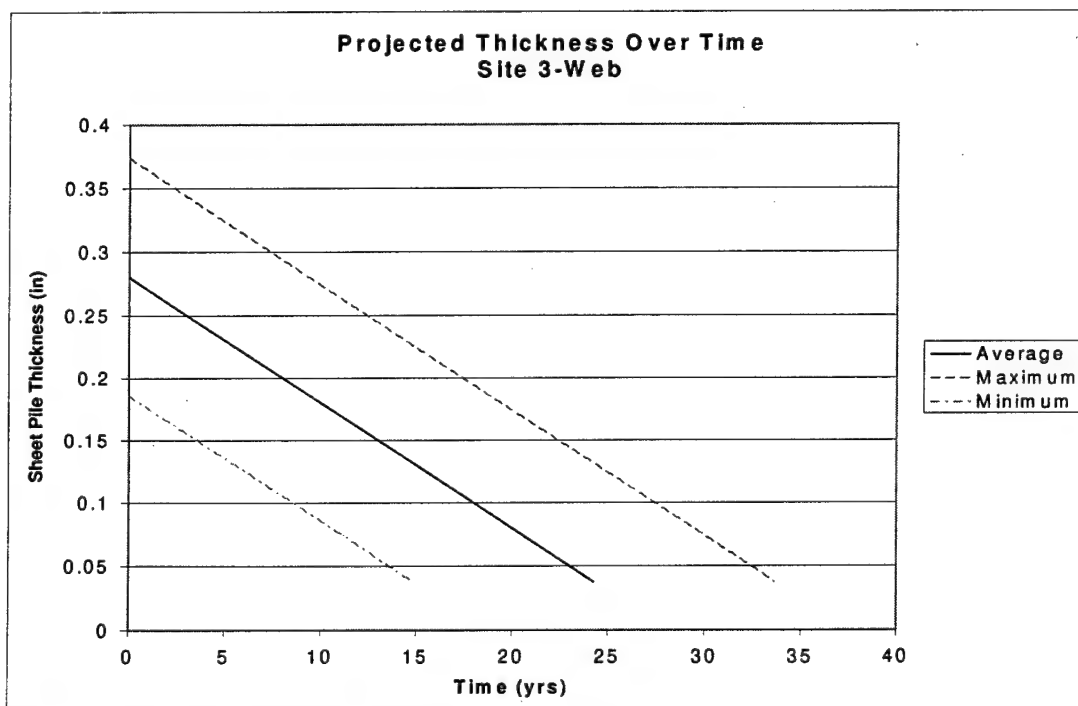
Figure 12. Site 3 web thickness projected over time.

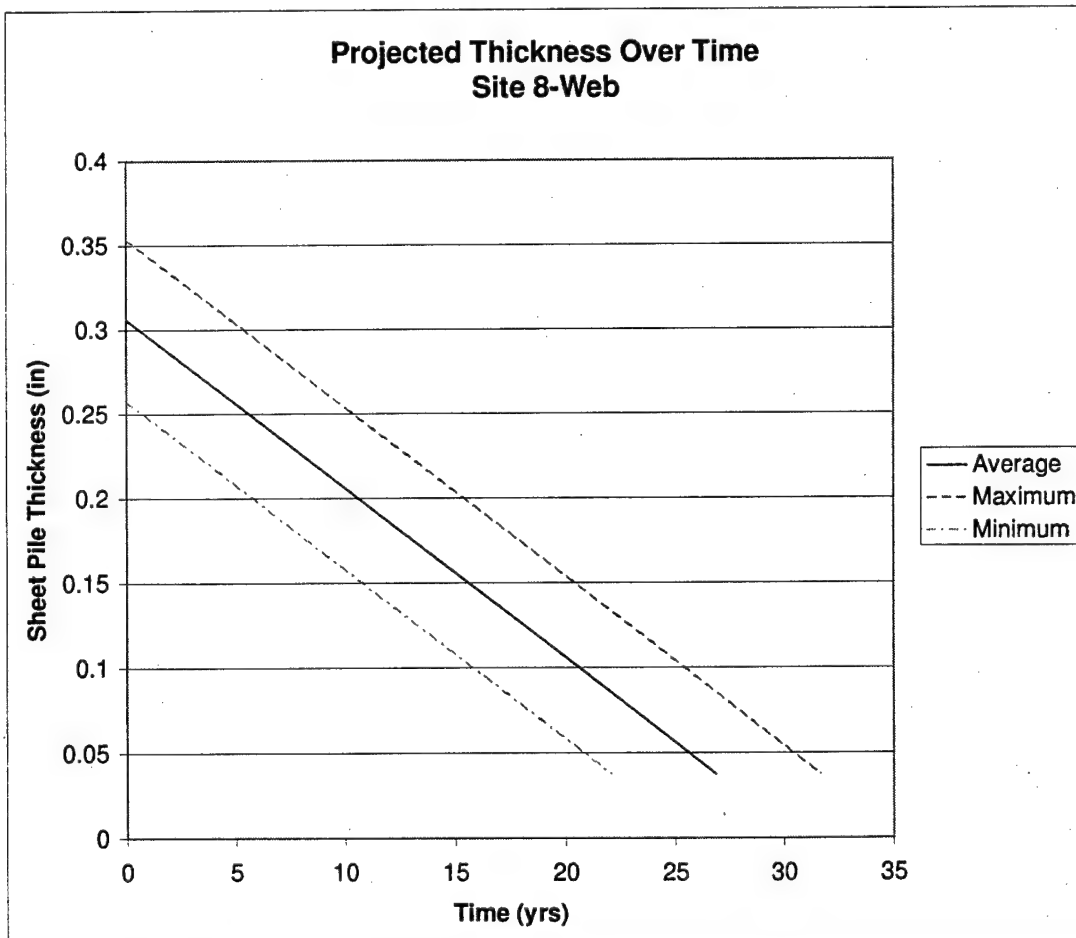
Figure 18. Site 8 web thickness projected over time.

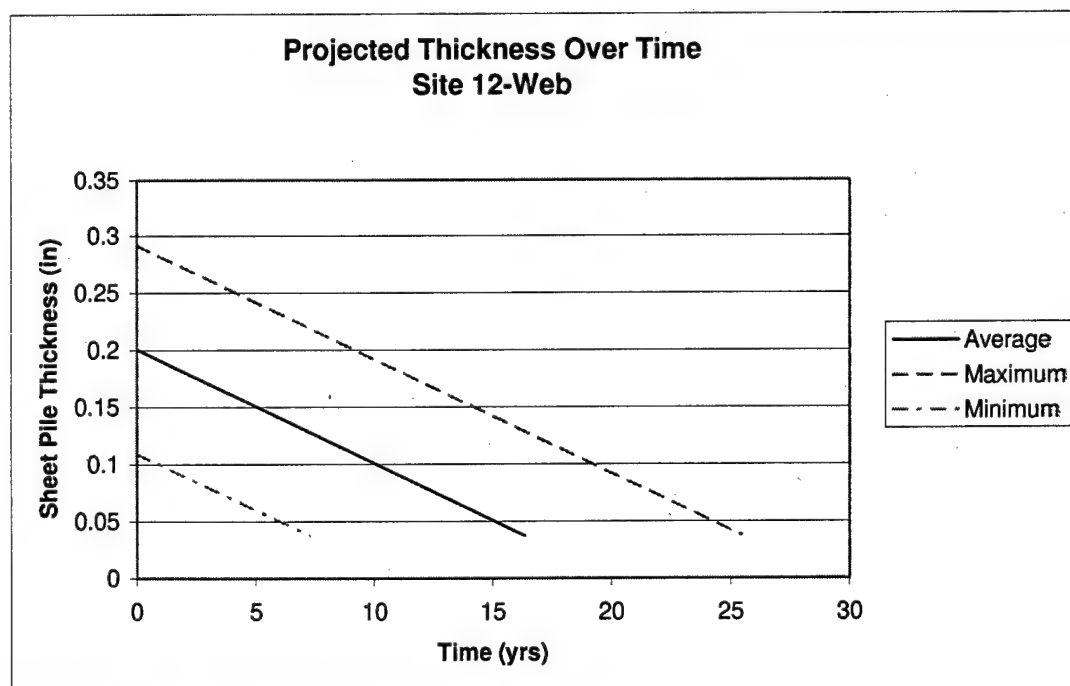
Zebra mussels are present in Lake Erie, but they were not found in great numbers at any site surveyed except for Site 12. Since Site 12 is closest to Lake Erie, a reasonable conjecture is that the encroachment of zebra mussels will proceed inland, assuming adequate initial environmental conditions for growth and reproduction. Although the rate of this migration is unknown, it is likely to adversely affect the corrosion rate of installed sheet pile. Experience at Black Rock Lock in Buffalo, NY, suggests that zebra mussels increase the corrosion rate by a factor of 5 compared to the rate in noninfested water. On the plus side, as filter feeders, the Zebra mussels are likely to have a positive effect on the clarity of Cuyahoga River water. It seems prudent therefore, to verify both the encroachment patterns and accelerated corrosion rates before considering available options for control.

Figure 22. Site 12 web thickness projected over time.

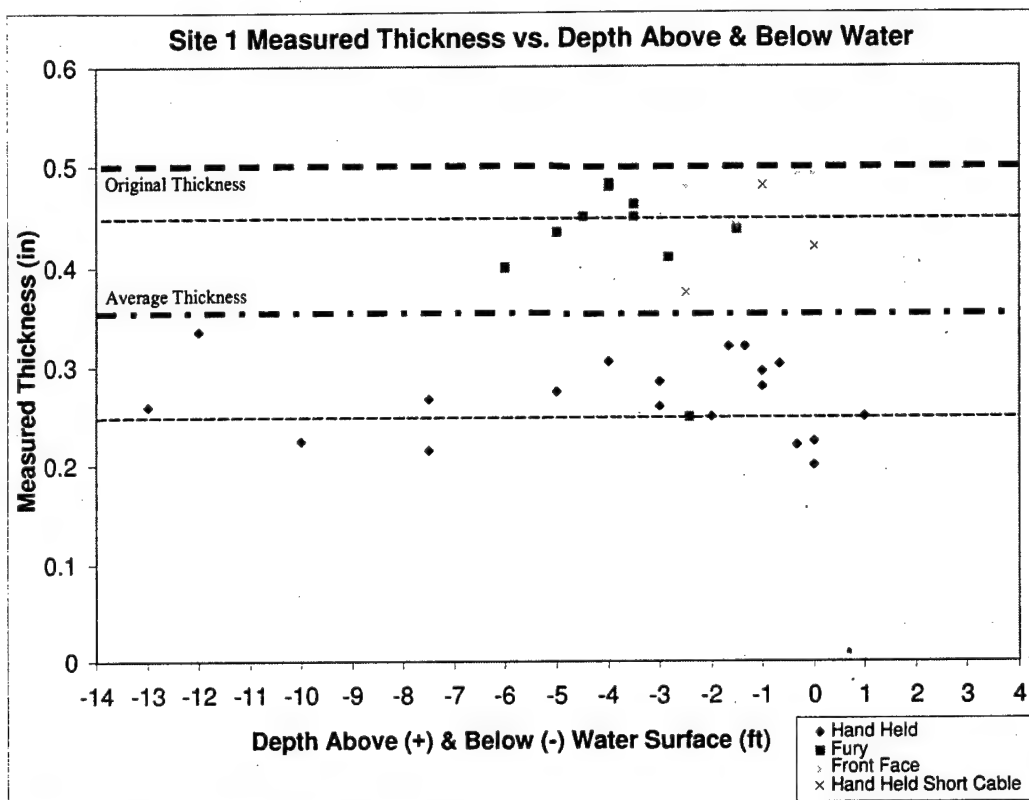
Figure 23. Site 1 thickness measurements.

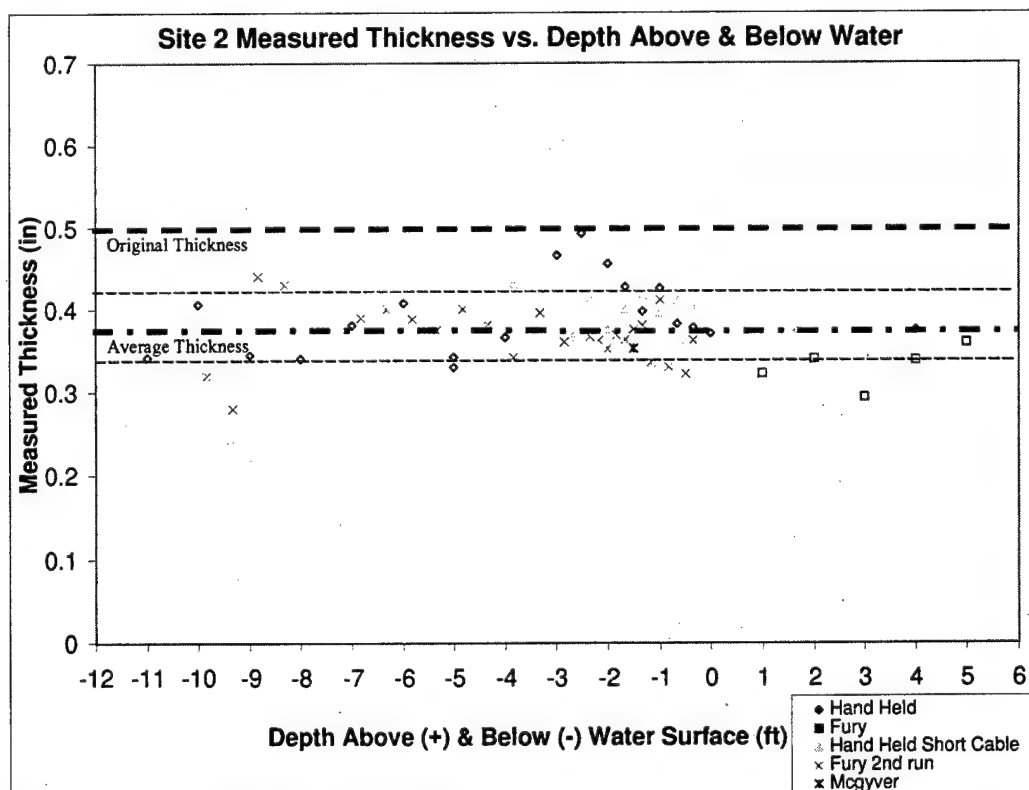
Figure 24. Site 2 thickness measurements.

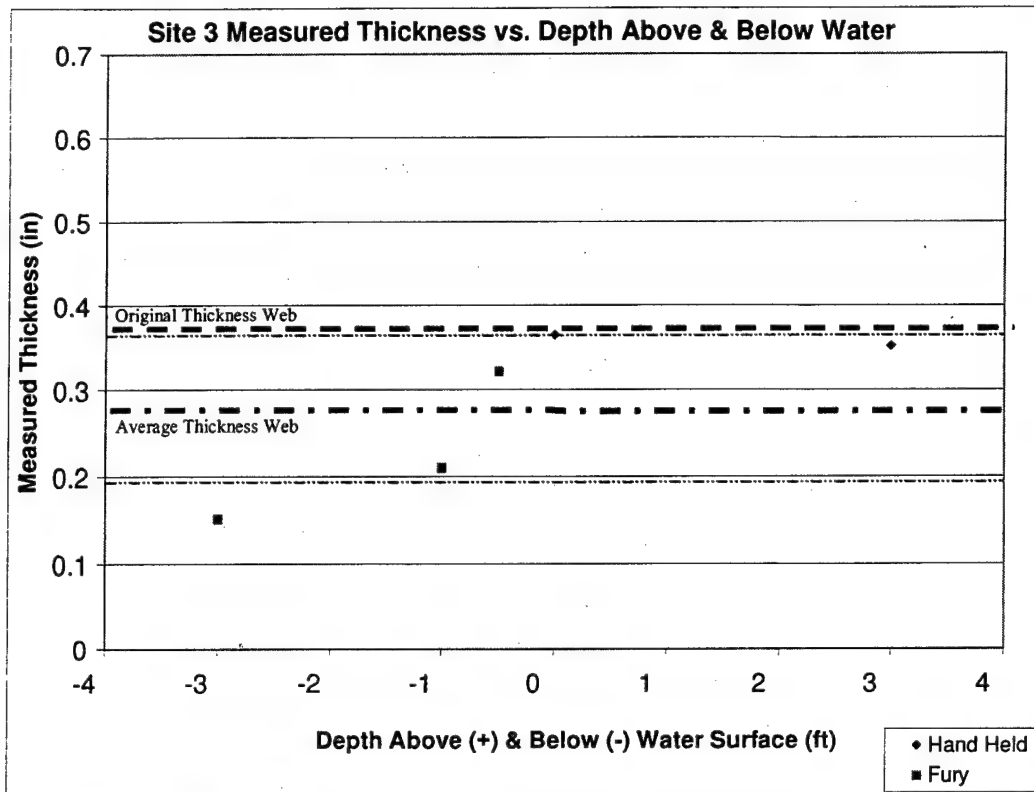
Figure 25. Site 3 thickness measurements.

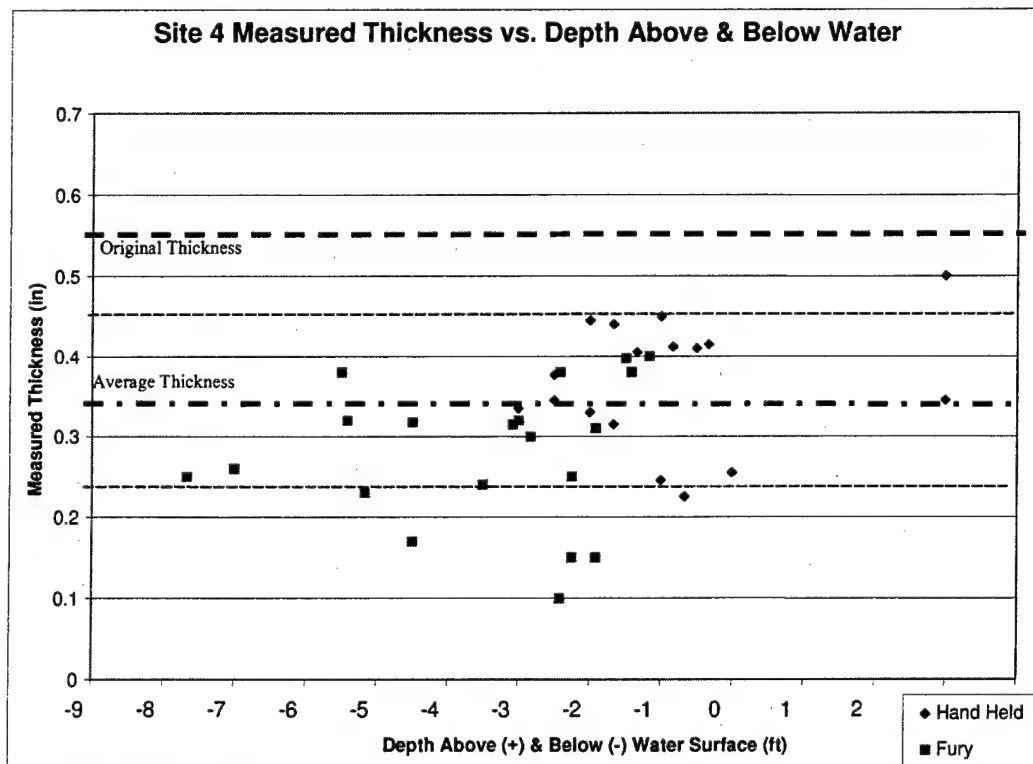
Figure 26. Site 4 thickness measurements.

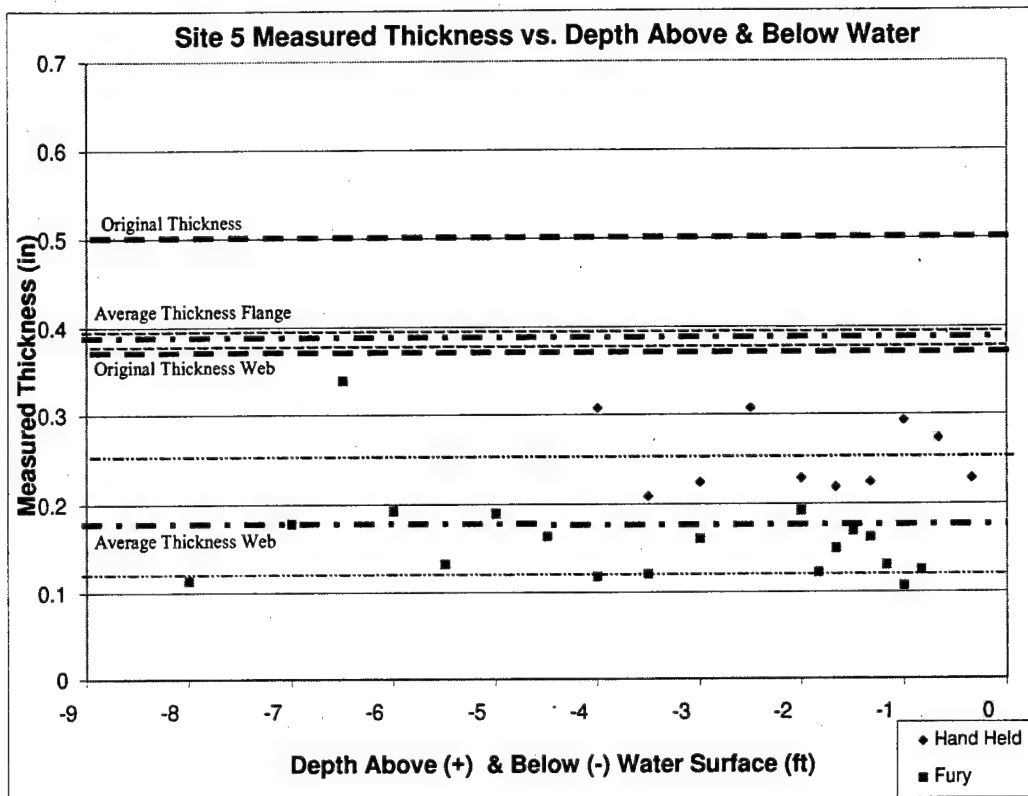
Figure 27. Site 5 thickness measurements.

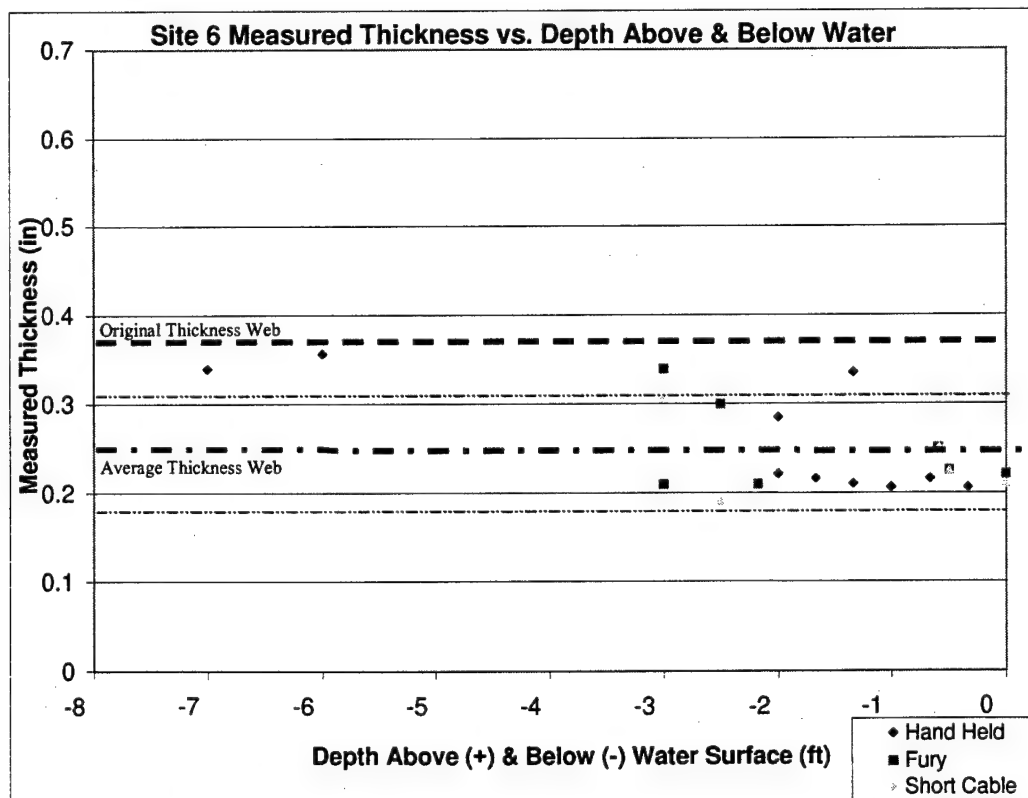
Figure 28. Site 6 thickness measurements.

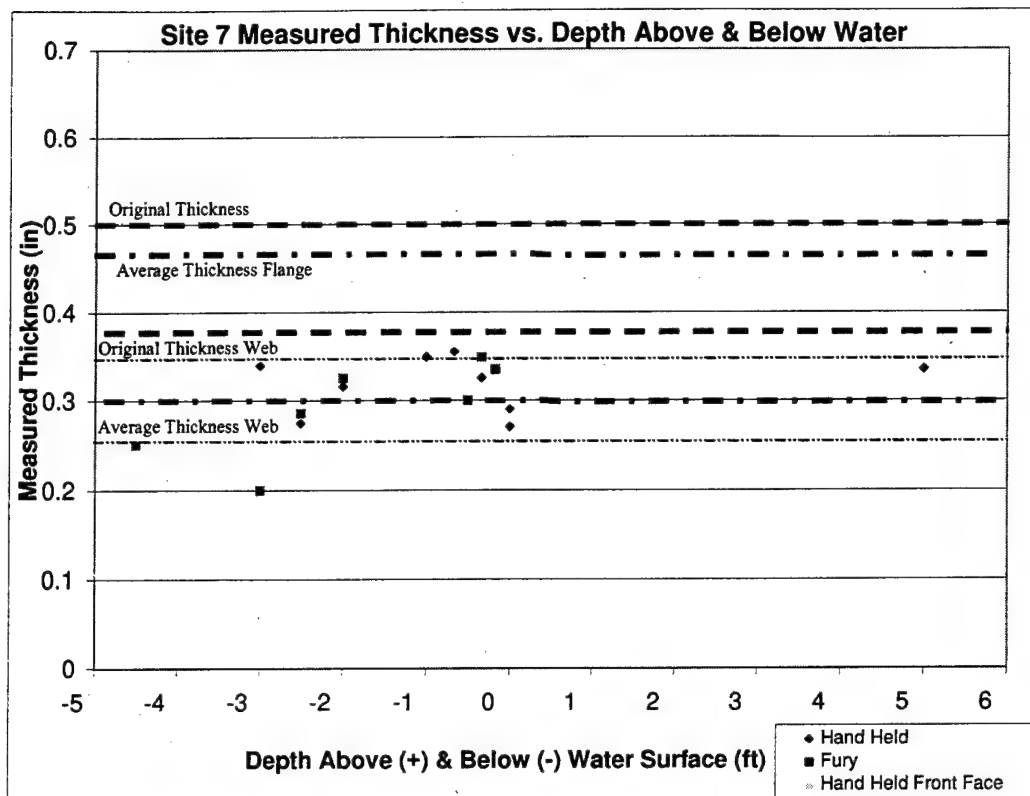
Figure 29. Site 7 thickness measurements.

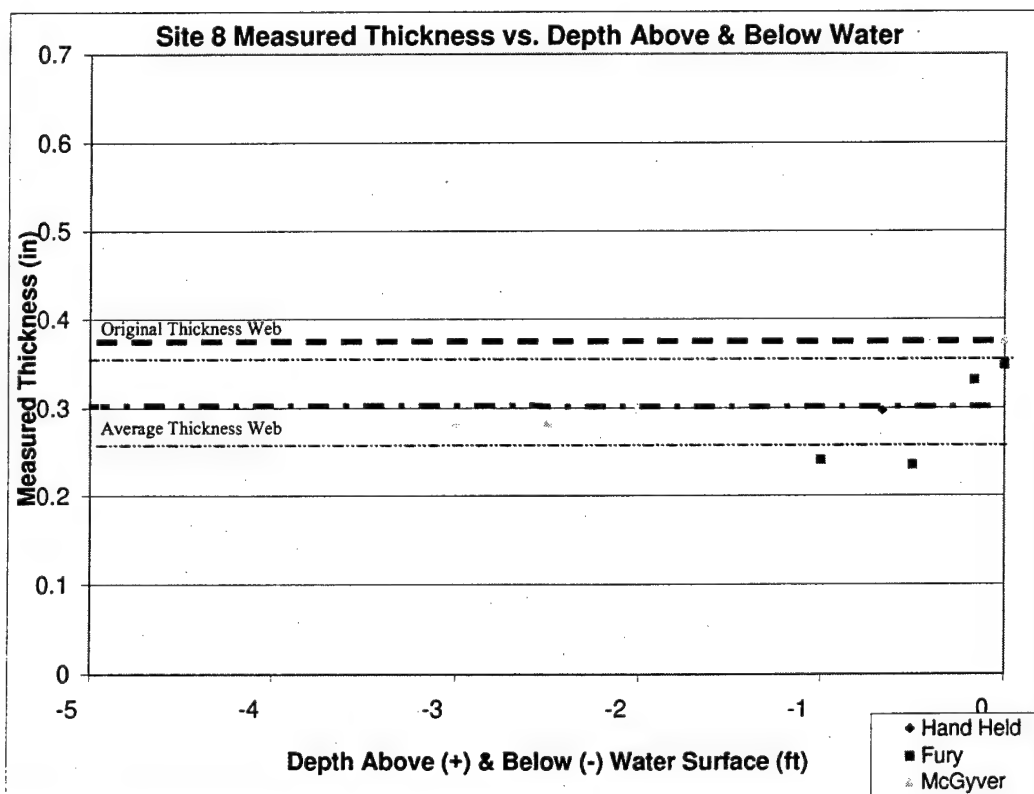
Figure 30. Site 8 thickness measurements.

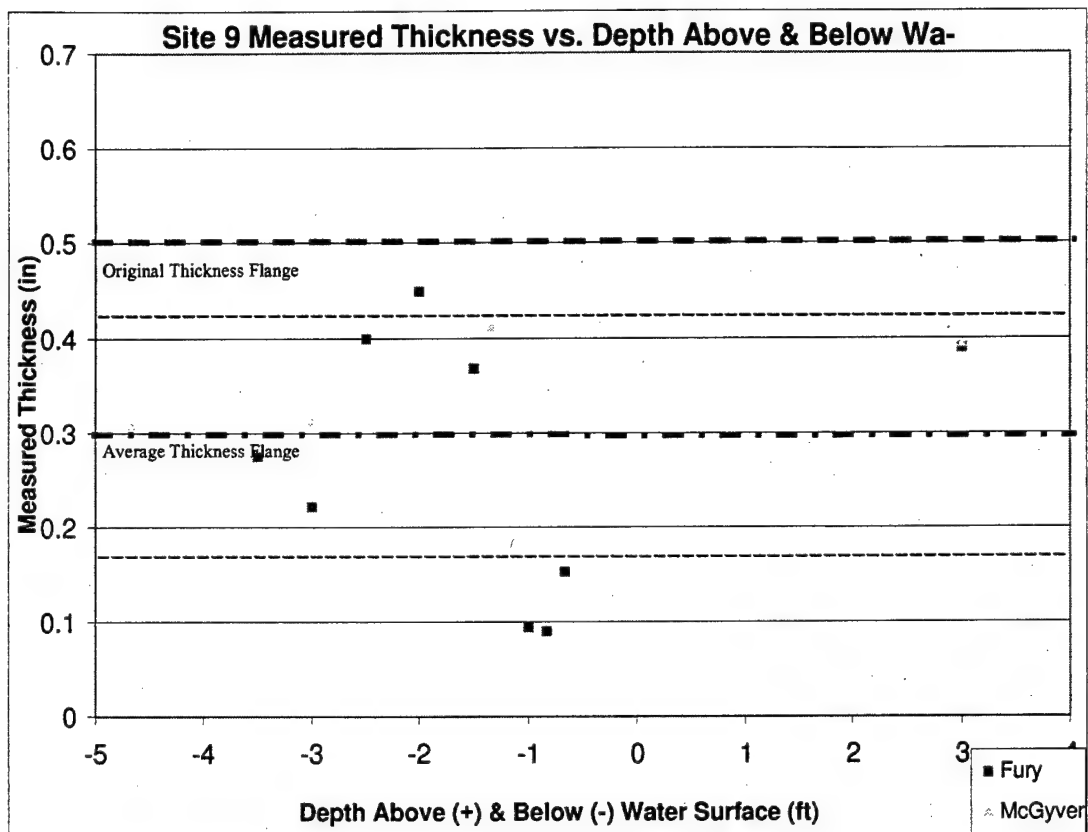
Figure 31. Site 9 thickness measurements.

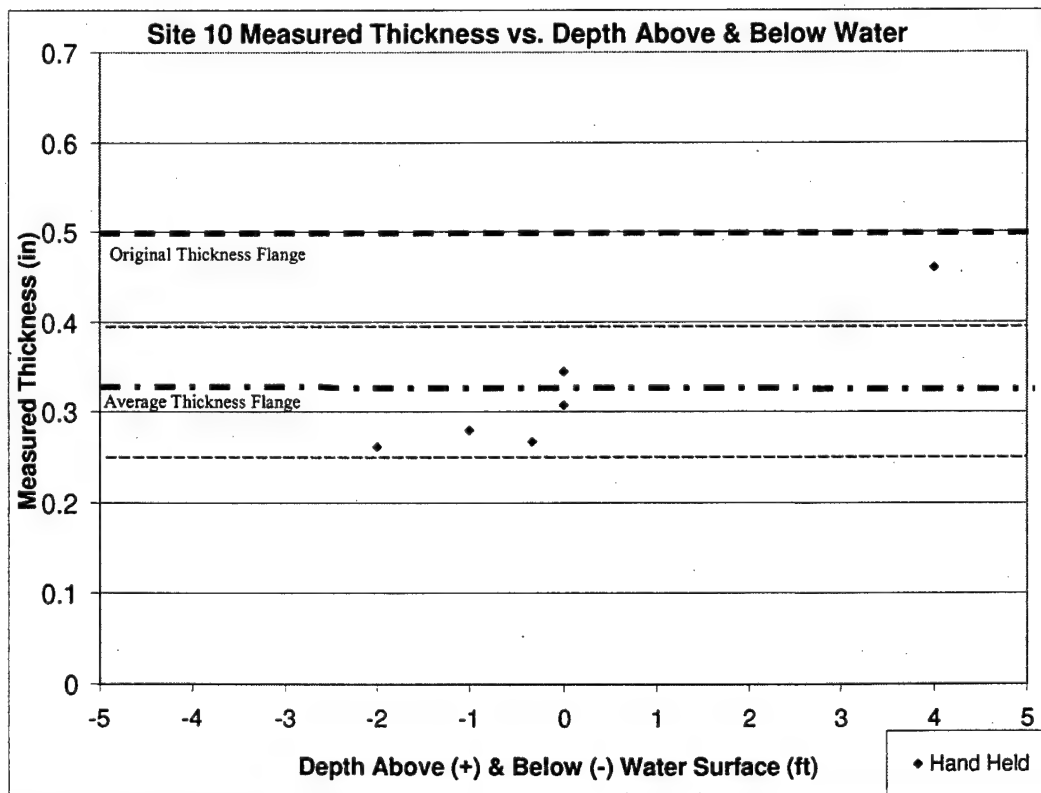
Figure 32. Site 10 thickness measurements.

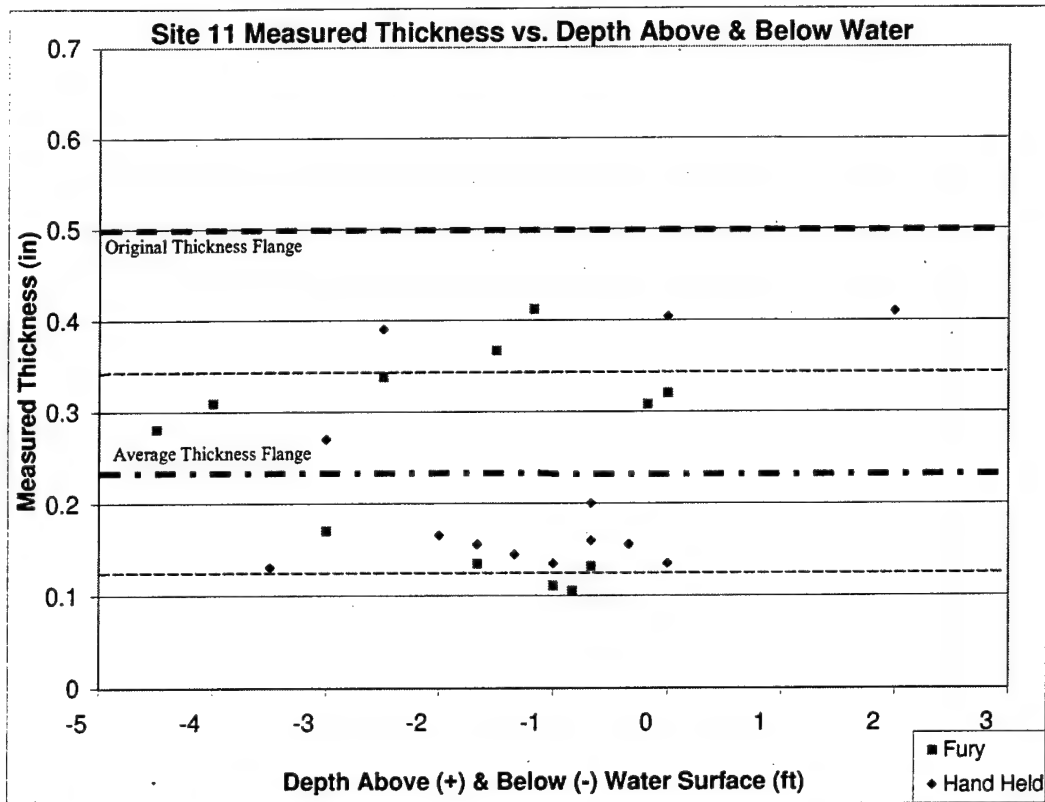
Figure 33. Site 11 thickness measurements.

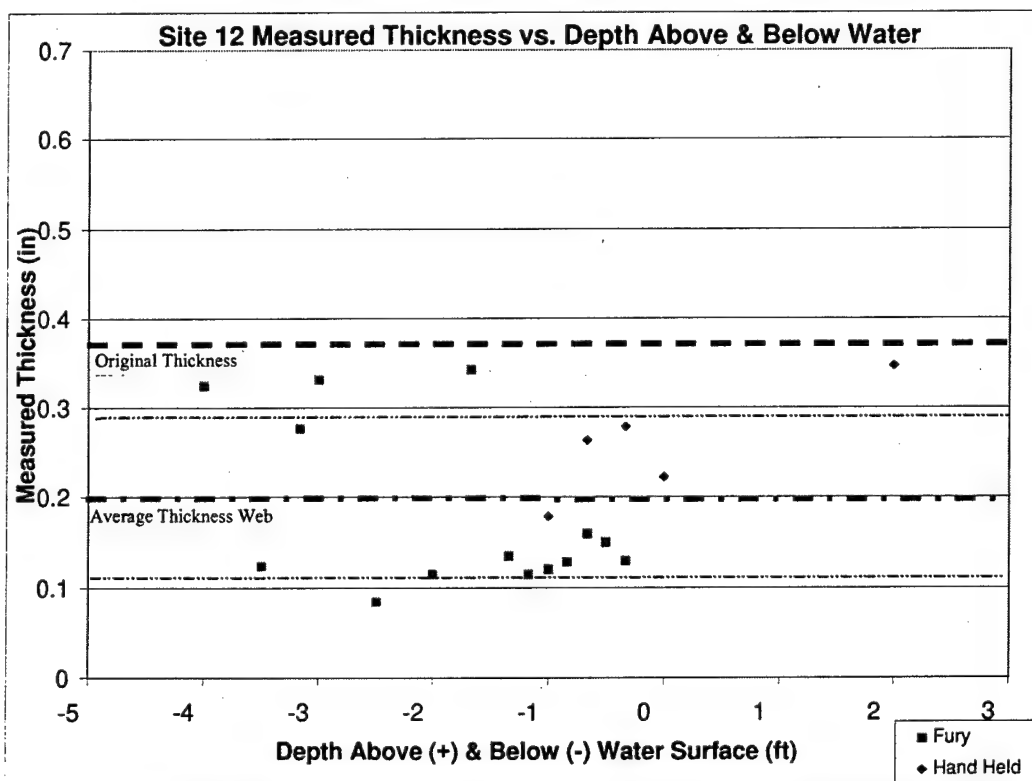
Figure 34. Site 12 thickness measurements.
